# 2018 ANNUAL MONITORING REPORT

# TRPA Annual Monitoring Report - 2018

**Prepared by:** Sean Tevlin, Assistant Environmental Specialist

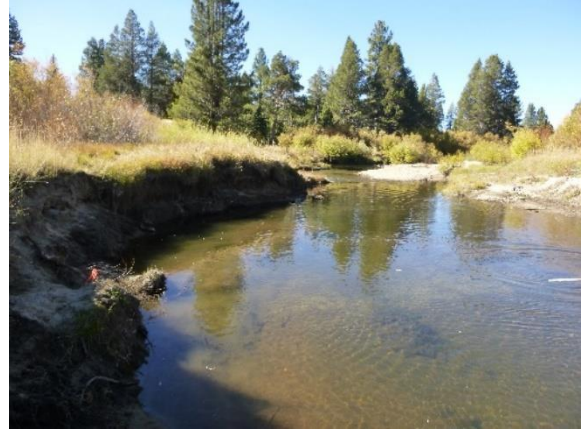
*Severe erosion along the Upper Truckee River.*

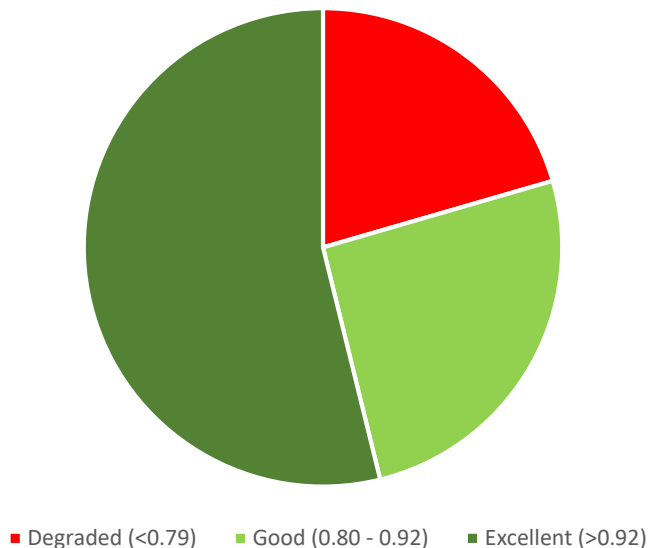
*2017 Stream Monitoring Results (40 sites)*

**Results:** Because lab processing of stream results takes a year, this report focuses on stream results from 2017, not 2018. In 2017, 40 total stream sites were sampled. The summer of 2017 was one of the largest runoff years in Tahoe ever recorded thanks to the record-breaking precipitation in the winter of 2016/2017. Therefore, the drought-related

stresses on streams from the past years were absent and instead streams were filled with plentiful water all summer.

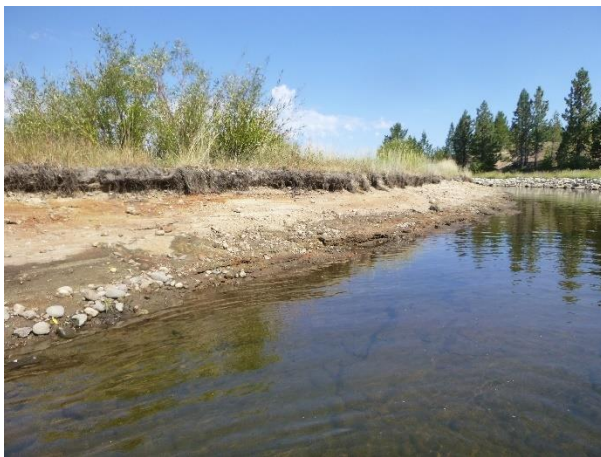
*The Upper Truckee River – Airport Reach was restored in 2012. It shows a degraded BMI community and increased bank erosion in 2017.*

- Five sites were sampled on completed restoration sites. Four of these sites had good or excellent health for BMI, indicating successful restoration. One site, the Upper Truckee River along the Airport Reach (completed in 2012) remained in marginal health and showed signs

of increased bank erosion.

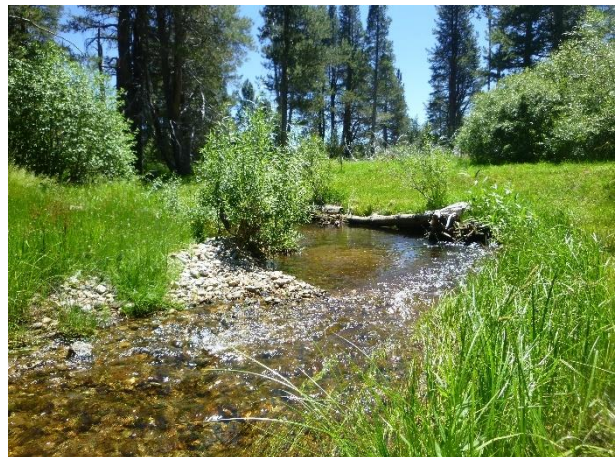
*Angora Creek below View Circle was restored in 2010. It shows excellent BMI health and little to no stream bank erosion.*

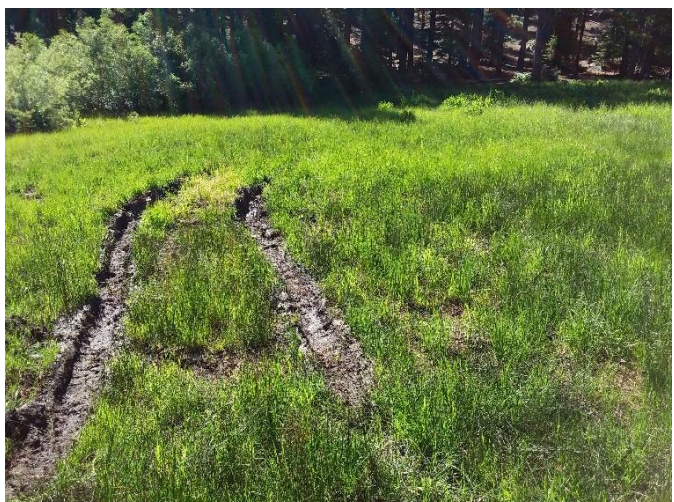
*Evidence of motor vehicles in a meadow near Stateline, NV*

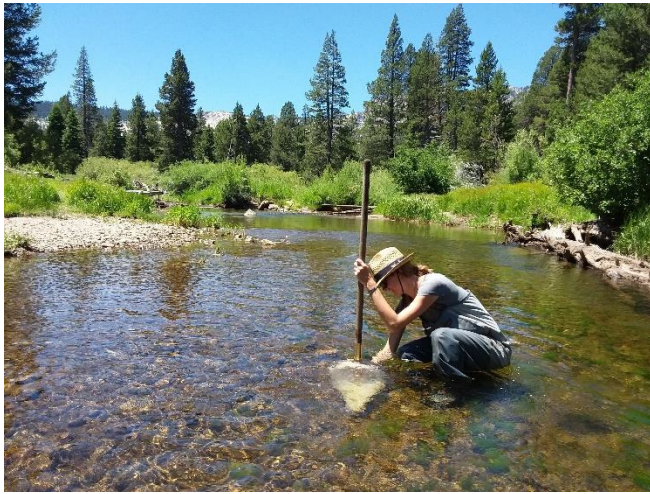
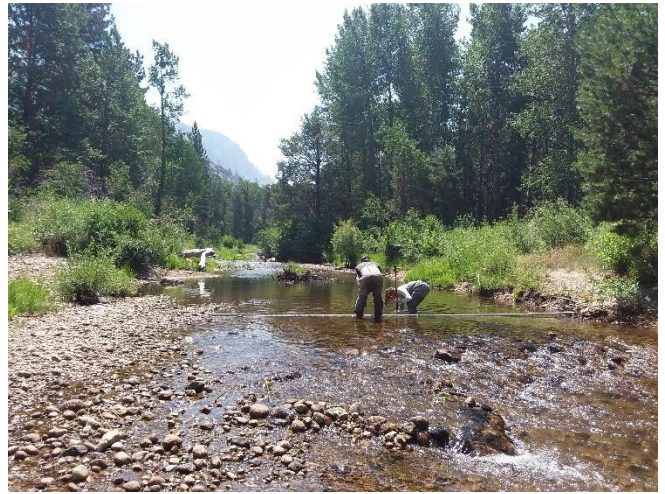
*Collecting macroinvertebrates (BMI) throughout the Tahoe Basin. BMI are an indicator of water quality and overall stream condition.*

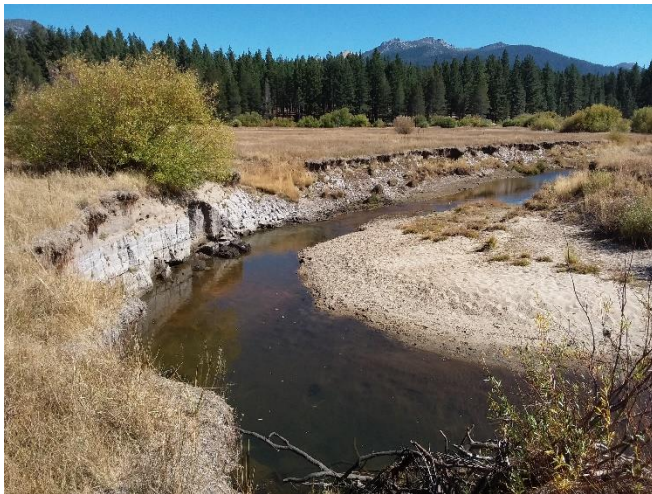
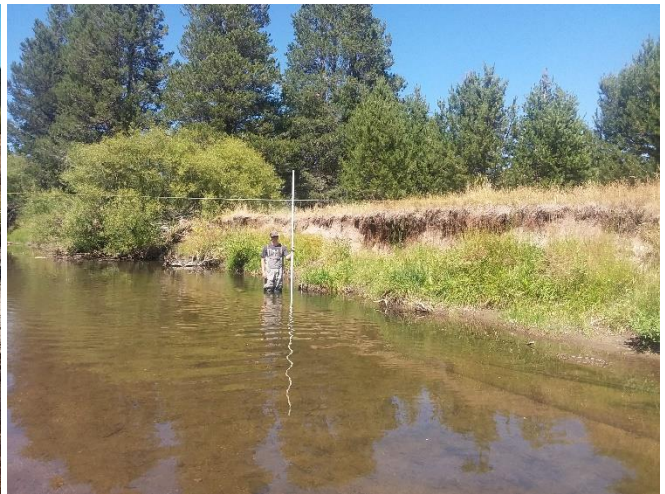
*Channel incision and bank erosion continue to impact some meadows in the Tahoe Basin.*

- Most wetlands / meadows sampled were healthy and functioning.
- Over 25% of the 41 sampled sites were not functioning properly due to channel incision

or ditching through the meadow.

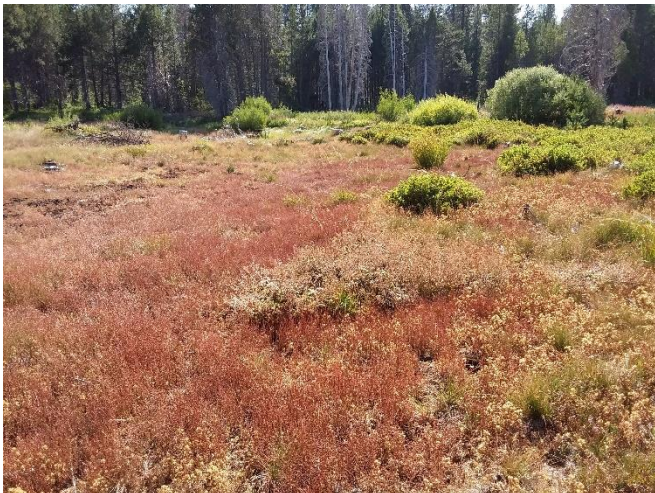
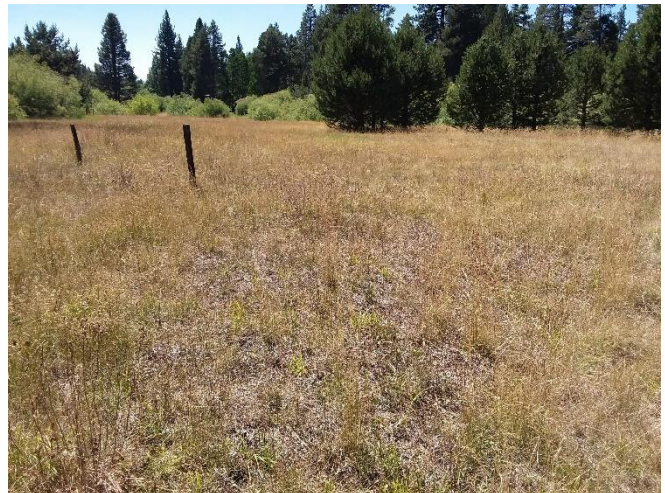
*Past land use practices such as grazing have left some meadows in the Tahoe Basin drier than normal and no longer provide the same critical functions a healthy meadow provides.*

- There are a relatively large number of meadows still suffering from degradation caused by past land use practices such as railroad building, grazing, and development in meadows.

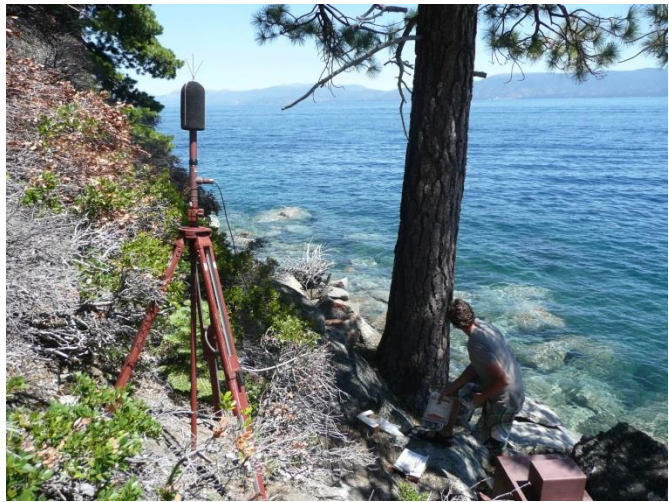
*A shorezone noise monitor deployed on Rubicon Point.*

**Shorezone:** TRPA has monitored noise from motorized watercraft in the shorezone of Lake Tahoe since 2009. Normally, there are 10 locations monitored for two weeks during peak boating season ( July Fourth through Labor Day). Every noise event that exceeds 75 dB is automatically recorded. All recordings are then analyzed to determine whether they came from motorized watercraft. In 2018, only one site was monitored. Rubicon Point was monitored in 2018 because it consistently has the largest number of noise exceedances. In 2018, there were 31 noise exceedances caused by boats over 10 days for an average of just over 3 exceedances per day. 2018 showed a similar level of noise exceedances at Rubicon Point as 2017, with only a slight drop.

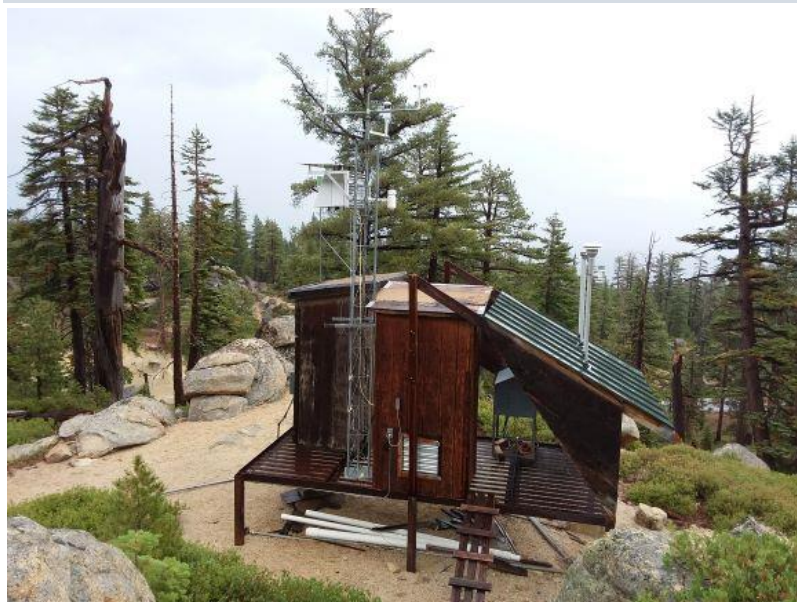
TRPA air quality monitoring station at DL Bliss State Park.

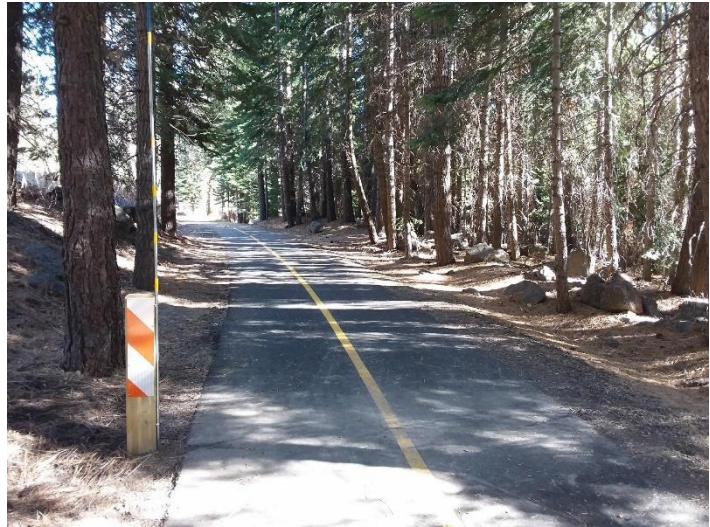
*A new bike / pedestrian counter installed on the Truckee River Trail near Tahoe City.*

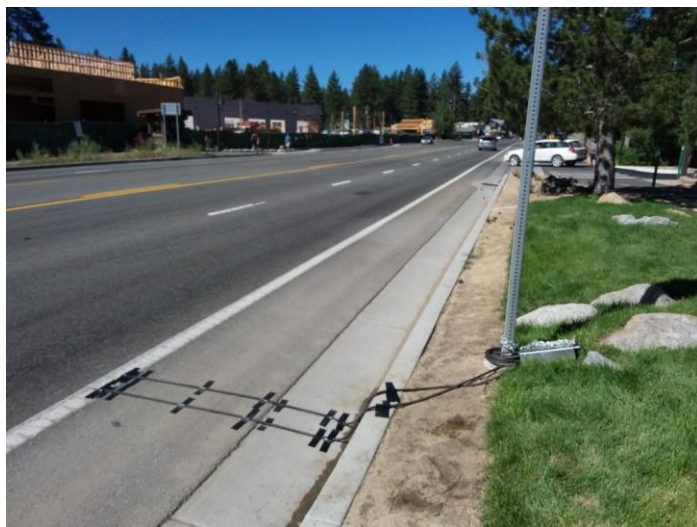
*A bike lane counter on US 50 near Ski Run Blvd in South Lake Tahoe.*

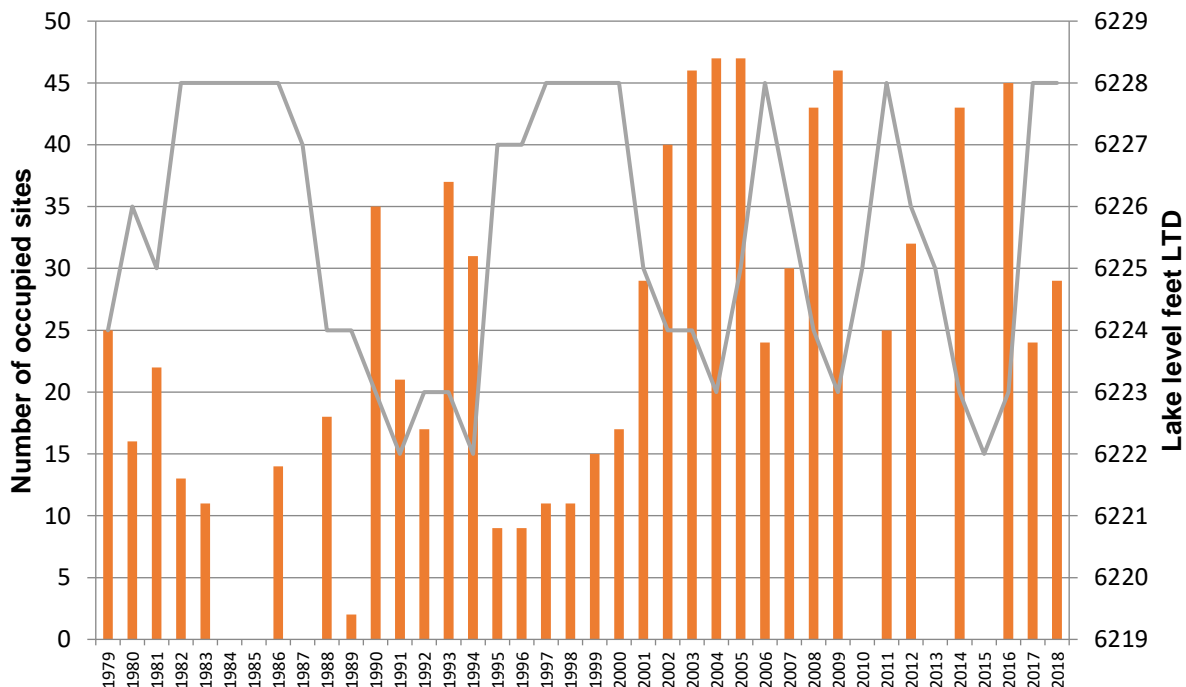
### Tahoe Yellow Cress survey results (up to 2018)

**Results:** In 2018, Lake Tahoe remained near its legal limit for the second summer in a row. This greatly reduced TYC habitat and surveys were initiated to ensure the plant is surviving despite the high lake levels. The 2018 survey results show a slight increase in the number of occupied sites over 2017, a great sign of TYC resilience despite high lake levels. The TYC population appears to be stable despite the high lake level.
